# INSPECTION REPORT

PRE-SHIPMENT INSPECTION · HOME APPLIANCE

Report No. IQC-20260902-BLANKET · Inspection date: September 2, 2026 · Sample report — client and supplier identities withheld

| Product Name | Electric Blanket |

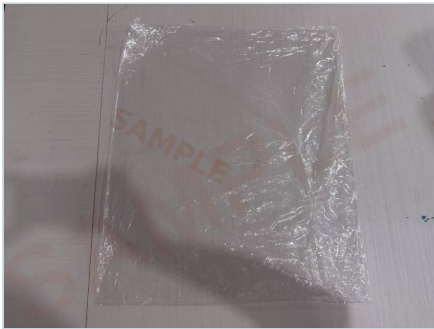
| ANSI/ASQZ1.4-2008, Single Sampling Plan: | | | | | | | |
|---|---|---|---|---|---|---|---|
| 1 | GL-BL14 | 80 | Loose threads | 0 | 3 | 3.76% | |

| Loose threads-Minor | Stains-Minor |

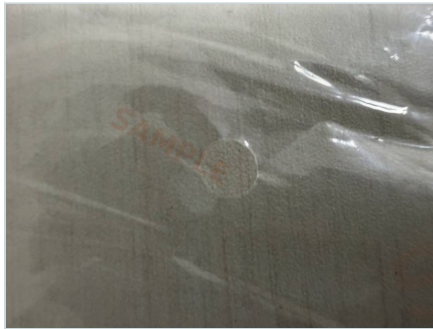
| ANSI/ASQZ1.4-2008, Single Sampling Plan: | | | | | | | |
|---|---|---|---|---|---|---|---|
| 2 | GL-BL14 | 80 | Stains | 0 | 2 | 2.5% | |
